# Manhole Inspection Summary

Manhole # S15A1\_016MH

**Inspection** ☐ Is Incomplete Rating: **2) Good**

**Location** Address: **1310 gloster av**

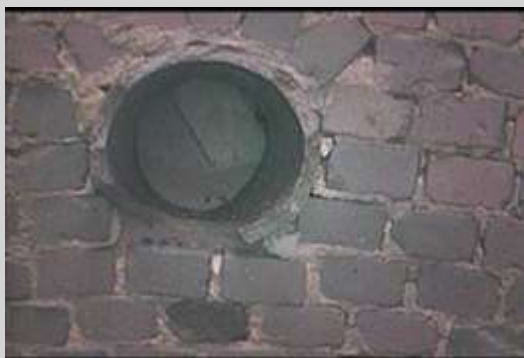
3 O'Clock Inflow

Pipe Height: **0** (in.)  
Pipe Material: ☐ Pipe Lined  
Invert Depth: **0.00** (ft.) Flow Characteristics:  
Deposits: ☐ None ☐ Mud ☐ Sludge ☐ Debris ☐ Grease  
Silt Depth: **0** (in.) Deposits Extent:  
Infiltration: Pipe Seal Cond:

Drop In @ 3 O'Clock
